Monitoring of Mining and Landfill Sites

Dainton Landfill Site

20 April 2016

Report prepared by Devon County Council

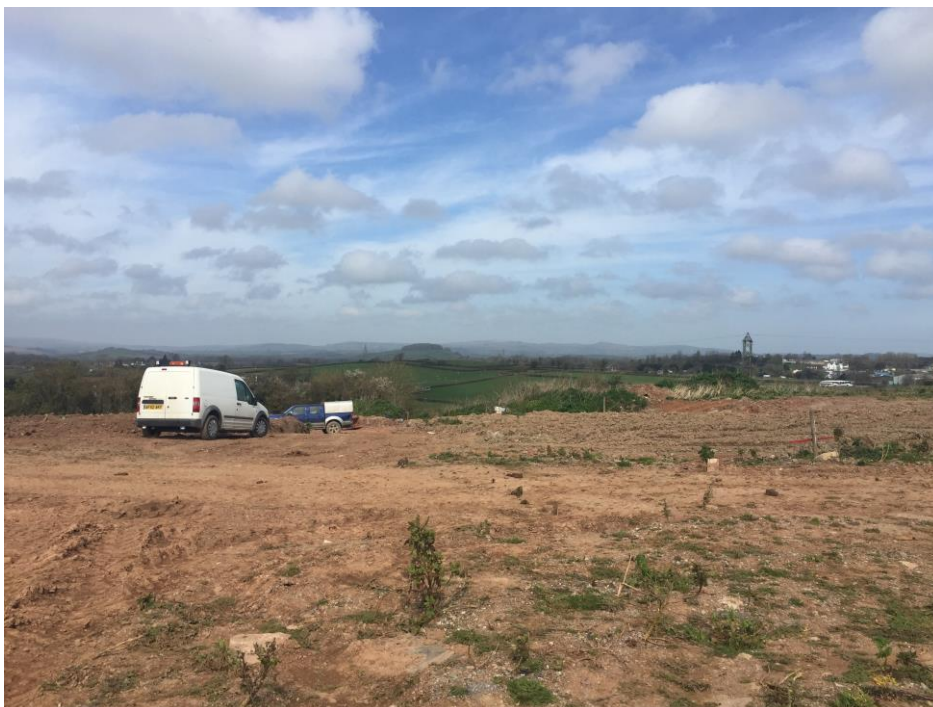
Looking north-west over Phase 5 – this is currently where the site is being regraded

1. The site has not been worked in accordance with the approved phase plan. Currently, material is being stored in Phase 4, and this phase and Phase 5 requires the most work to level the site to the permitted levels.
2. The site is in the process of being levelled – the completed areas meet the existing contours
3. No tipping was seen within the crown of any tree.

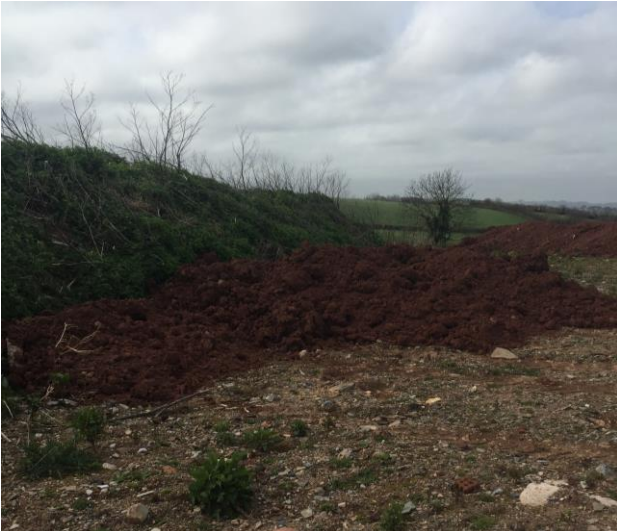
New top soil that that been brought onto the site – this is in the centre of the site, outside of the Temporary Soil Storage Area

4. The top soil stores are currently outside of the 'Temporary Soil Storage area' in the middle of the site and there are a number of other top soil heaps in the south eastern area of the site. It is considered the locations of the soil are not causing harm to the local environment in their current position, and therefore, no action is required by the operator. The locations allow for the soils to be spread over the remaining areas once tipping operations have finished.

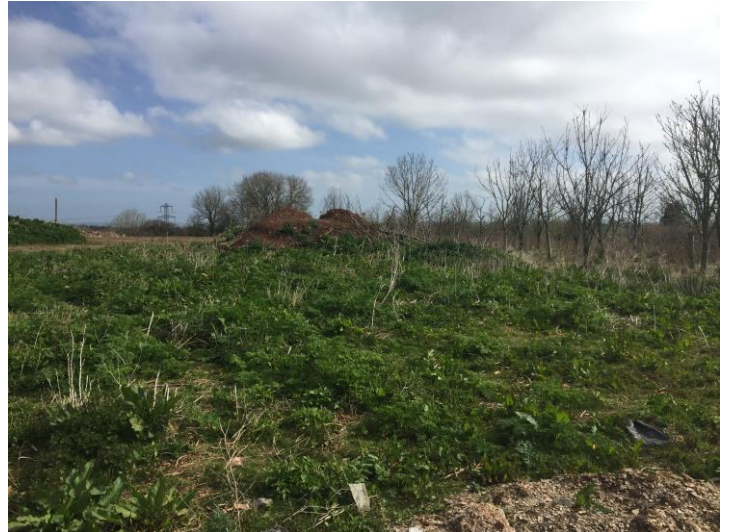
Trees on the south-eastern boundary of the site – this area is covered in vegetation, which will require removal prior to the spreading of top soil.

The parts of the site that have reached the permitted levels and the topsoil heaps are covered with vegetation, including weeds. These will need to be cleared prior to the spreading of topsoil as per the reinstatement methodology outlined in the Agricultural Appraisal dated 29 September 2008 (submitted as part of 10/01076/DCC). The County Ecologist has advised that the weeds should be mechanically cleared prior to the spreading of the topsoil. This needs to be completed before the end of summer as this is when the weeds will seed themselves.

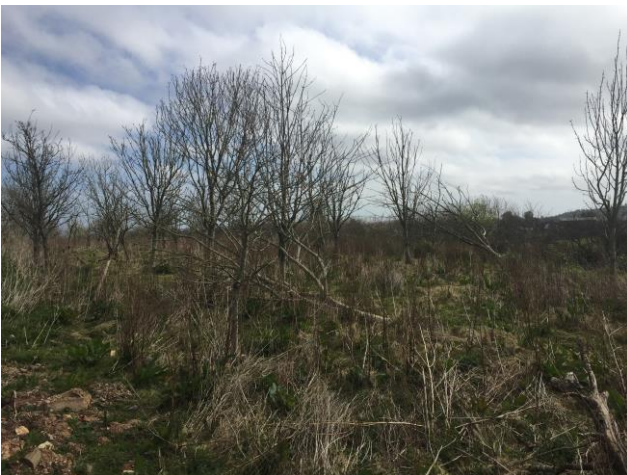
Trees on the south-eastern boundary of the site, a large number of these appeared to have failed – this will be addressed in the restoration of the site

The main concern that has arisen from the monitoring visit was that the site has not yet begun restoration and that the planting that has occurred so far differs from that shown on the 'Landscape Proposals' plan (Drawing-DR-01). The operator stated that the location of the planting had been agreed on previous monitoring visits due to the way in which the site could be worked during wet weather. The trees are now located along the south eastern boundary of the site - crossing Phase 2, 4 and 3.

Following the site visit, a discussion with the landowner has taken place. It was agreed that a plan would be provided to show the agreed changes and that this should ensure all of the principles from the approved documents are included. The landowner stated this would be before the end of May.

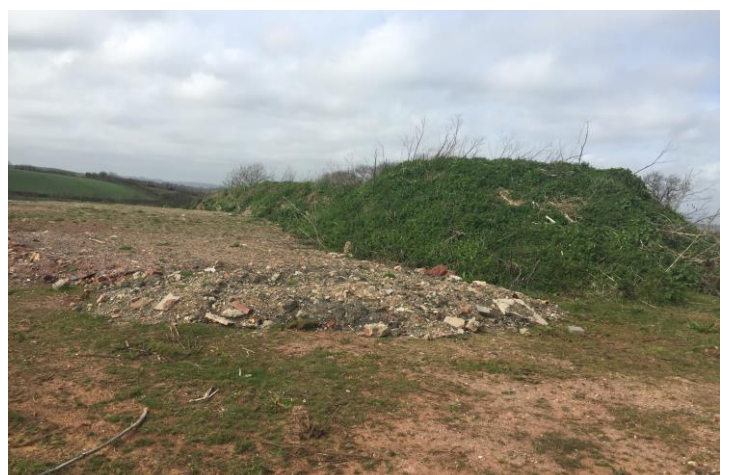
Top soil stores in the centre of the site with the material in Phase 2 still requiring regrading into the existing levels
